## PIPE REPAIR BANDAGE CASE STUDIES

# DIRECTIONS FOR USE

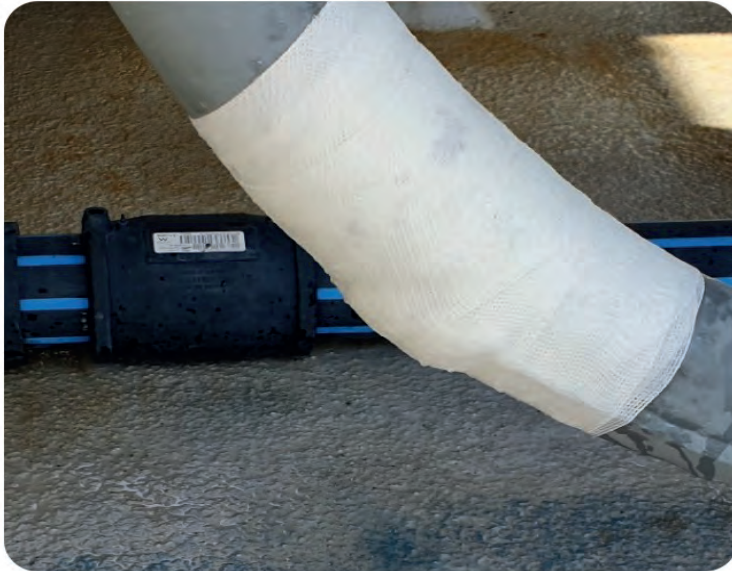
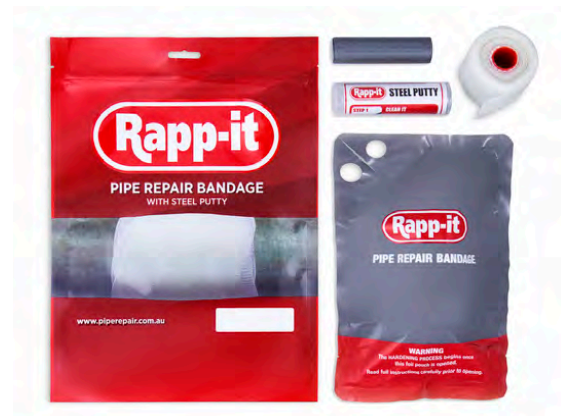
The customer advised they had a leak in the acid column outlet bend to the extraction column as part of the stripping circuit in gold production. The bend had previously been repaired with a steel patch, but a leak occurred just above the repair weld.

Pipe Substrate	Steel
Pipe Contents	Saturated carbon, hydrochloric acid, caustic solution
Pipe Diameter (mm)	100mm
Damaged Area (mm)	Pin-hole leak

The customer reduced the line pressure and then cleaned and roughened the area. The leak was stemmed with Rapp-it Steel Putty and a Rapp-it Pipe Repair Bandage (100mm x 3.6m) applied over the top. The line was up and running at full capacity, 30 minutes after application.

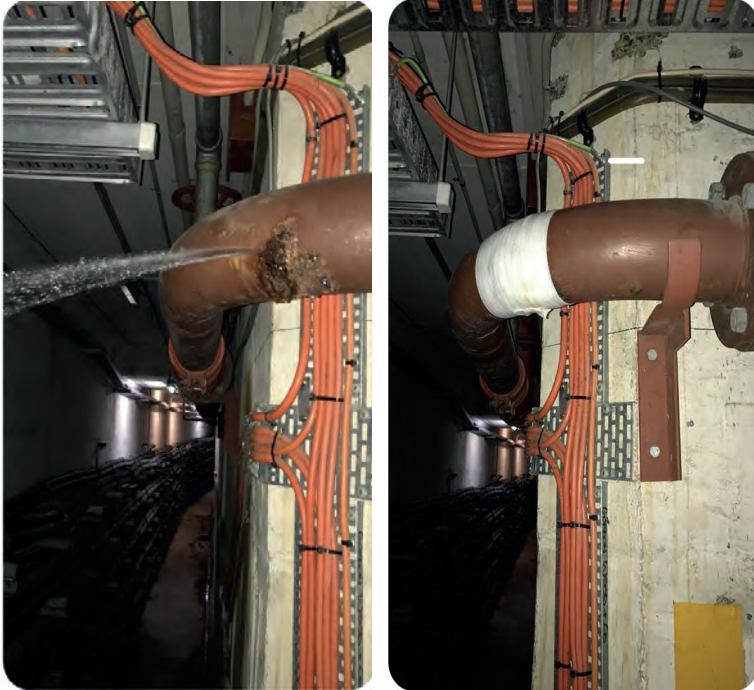
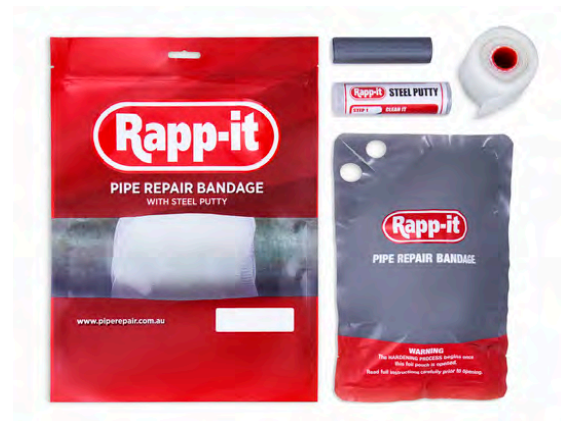
The customer advised that they had an overhead leak in a 100mm water main line. The pipe required urgent repair, as the damaged area was dangerously close to electrical conduits which was creating a safety hazard.

Pipe Substrate	Steel
Pipe Contents	Water
Internal Pressure (psi)	116 psi / 800 kPa
Temperature (°C)	7°C – 15°C
Pipe Diameter (mm)	100mm
Damaged Area (mm)	180mm

The customer reduced the line pressure and then cleaned and roughened the damaged area. The leak was plugged with Rapp-it Steel Putty and Rapp-it Pipe Repair Bandages (100mm x 4.8m) were applied over the top. The line was fully functional 30 minutes after application.

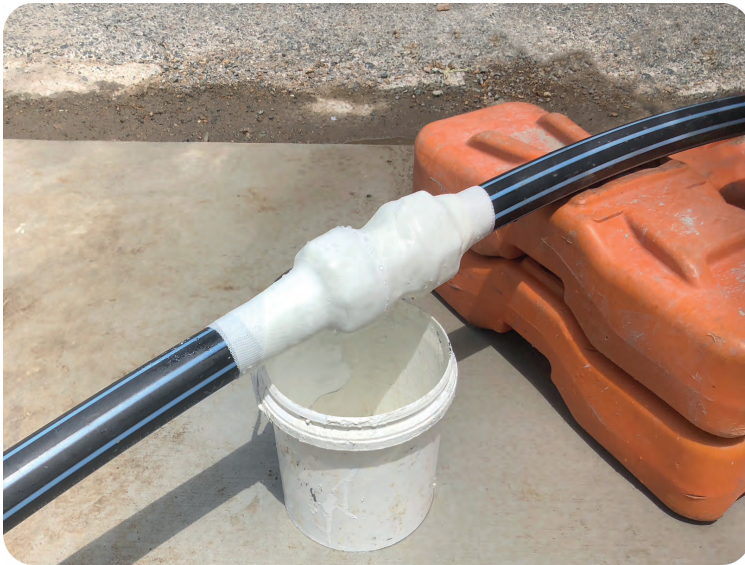
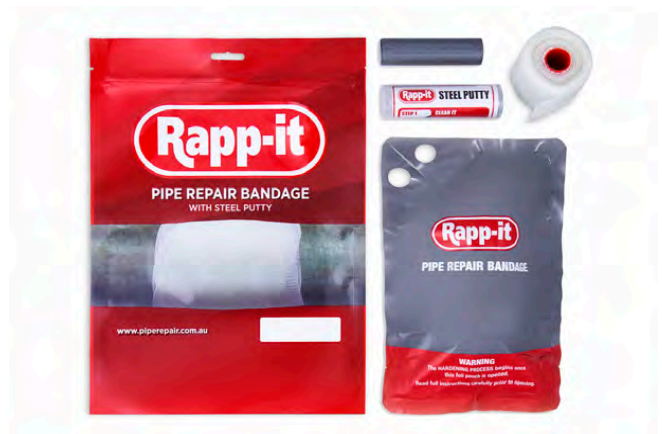
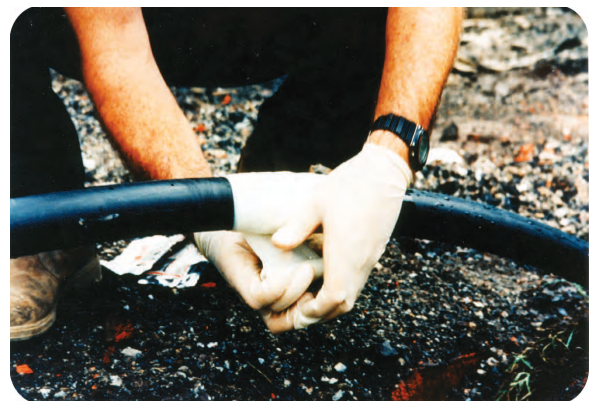
The customer had a leak on a poly pipe water line feeding the job site. The pipe could not be shut down and required an urgent temporary repair, as the water spillage on the ground was creating a safety hazard for construction workers accessing the area.

Pipe Substrate	Poly Pipe
Pipe Contents	Water
Internal Pressure (psi)	100 psi / 690 kPa
Temperature (°C)	Ambient
Pipe Diameter (mm)	100mm

The customer decreased the line pressure and then cleaned the area. As the leak was located close to a poly joiner, we advised that Rapp-it should be applied over the joiner to ensure the leak would be fully contained. Using Rapp-it Steel Putty and a Rapp-it Pipe Repair Bandage (100mm x 3.6m) applied over the joiner, the leak was successfully contained within 30 minutes with no further spillage onsite.

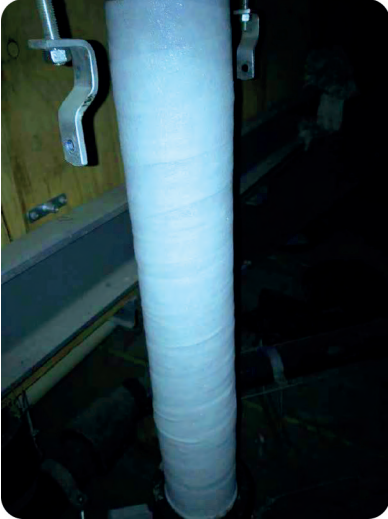
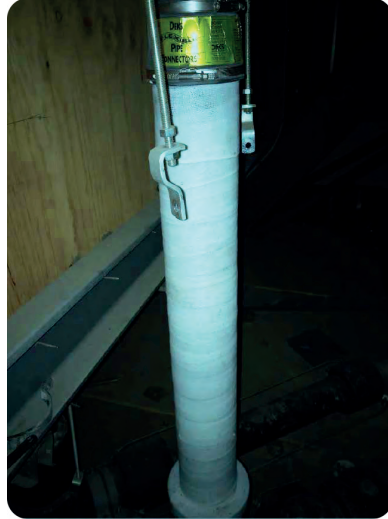
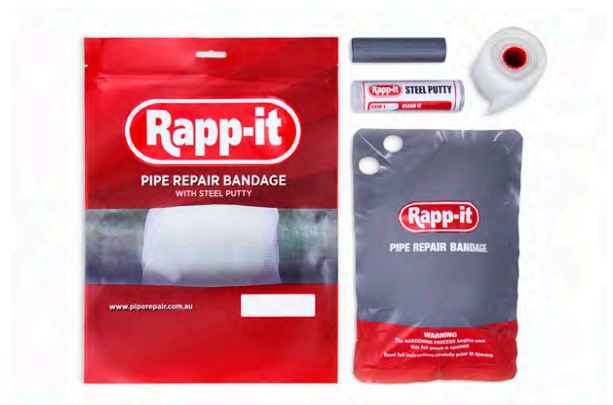
The customer had a leak in their 1992 vintage cement storm water run-off pipes. The pipes required urgent repair, as the damaged area was dangerously close to electrical, lighting and costumes. This was creating a safety hazard for all staff and patrons, as well as potentially damaging thousands of dollars worth of costumes.

Pipe Substrate	Cement
Pipe Contents	Water run off
Internal Pressure (psi)	100 psi / 690 kPa
Temperature (°C)	10°C – 20°C
Pipe Diameter (mm)	100mm
Damaged Area (mm)	20mm

After the customer stemmed the flow of water, and cleaned and roughened the pipe, they used Rapp-it Steel Putty and a Rapp-it Pipe Repair Bandage (50mm x 3.6m) to seal the leak. The successful application ensured no risk to staff or patrons, or costume damage.

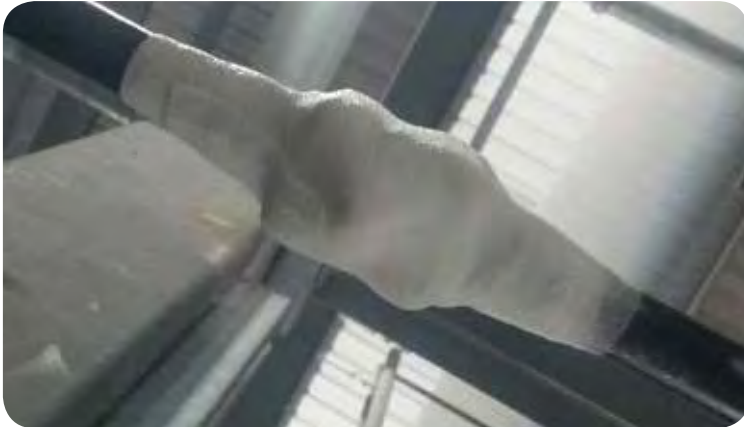
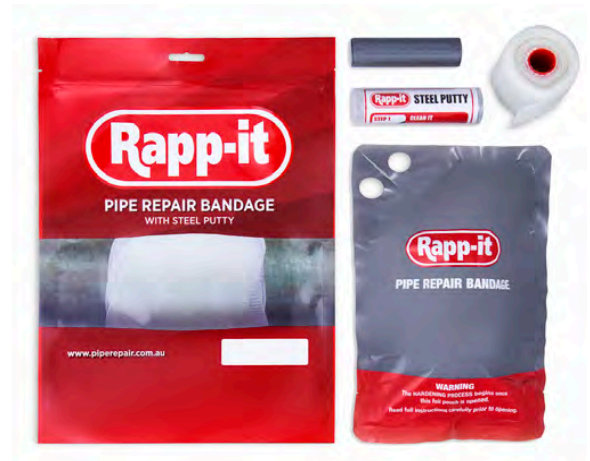
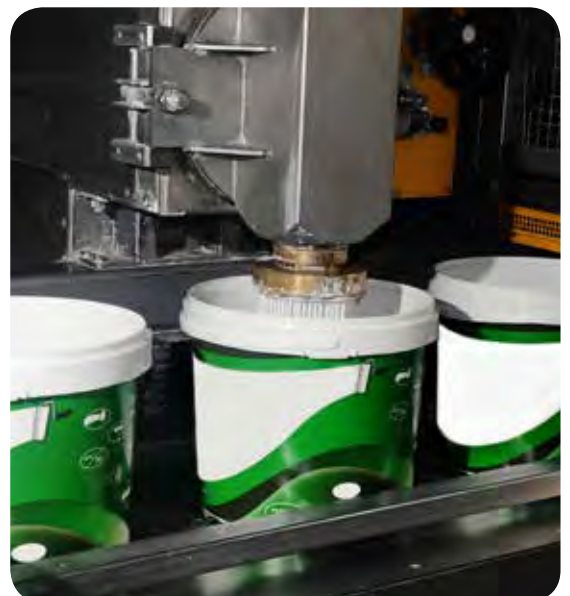
The customer had an overhead leak in a 25mm ball valve line. The valve required urgent repair, as the damaged area was leaking Texanol. Texanol is a widely used toxic liquid found in paint manufacturing.

Pipe Substrate	Steel
Pipe Contents	Texanol
Internal Pressure (psi)	116 psi / 800 kPa
Temperature (°C)	25°C – 30°C
Pipe Diameter (mm)	100mm
Damaged Area (mm)	25mm Ball Valve

The line was shut down and the damaged area was cleaned and roughened. Rapp-it Steel Putty and Rapp-it Pipe Repair Bandages (50mm x 3.6m) were applied over the ball valve line with 5cm tails on each side. The line was up and running at full capacity 30 minutes after application.

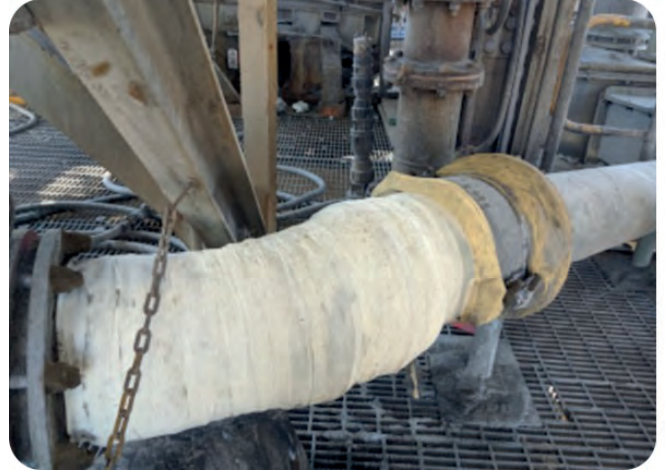
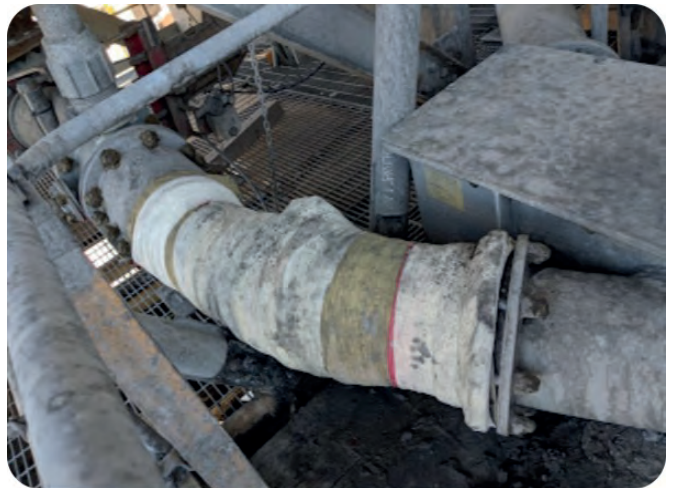
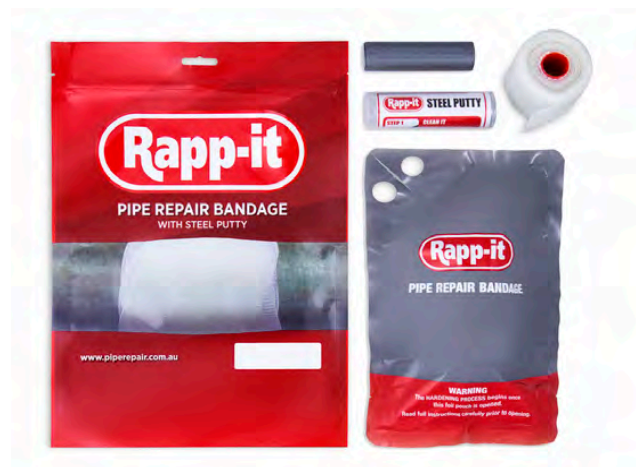
The customer had a damaged material handling hose due to the pressure and contents of the mineral ore running through it. The hose required an urgent repair or unplanned shutdown maintenance was needed, potentially costing thousands of dollars in unnecessary downtime.

Pipe Substrate	Industrial rubber hose
Pipe Contents	Nickel sludge
Internal Pressure (psi)	117 psi / 800 kPa
Temperature (°C)	0°C – 45°C
Pipe Diameter (mm)	250mm
Damaged Area (mm)	Multiple damaged areas

Industrial hoses are great for transferring harsh and abrasive products throughout processing facilities. However, sometimes abrasive materials can impact the integrity of the hose. In this example, the customer was unable to weld or clamp the hose. The customer applied 23 Rapp-it Pipe Repair Bandages (100mm x 4.8m) around the damaged area. The material handling hose was up and running at full capacity just 30 minutes after application.

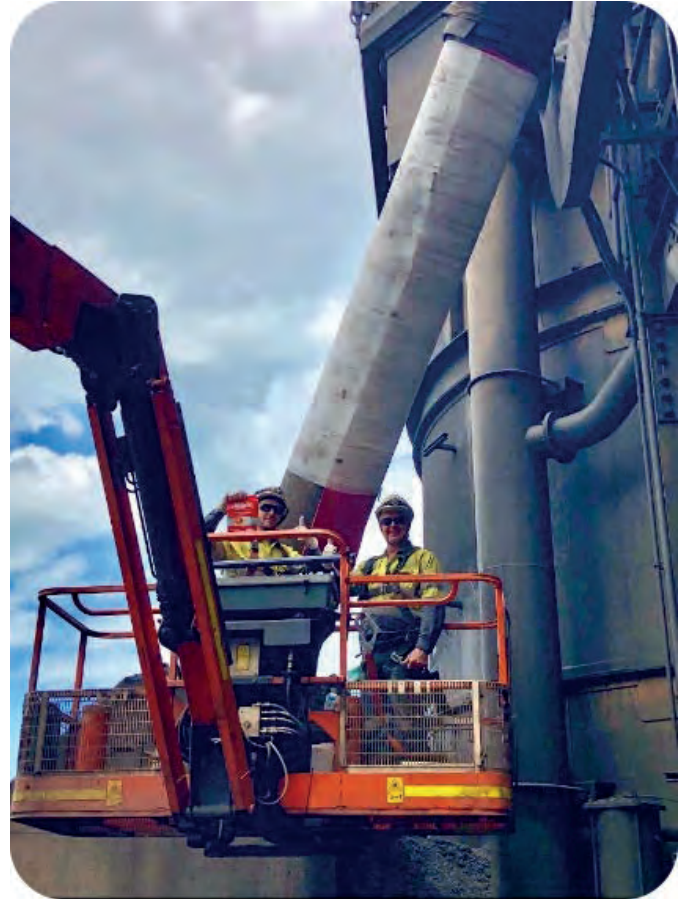
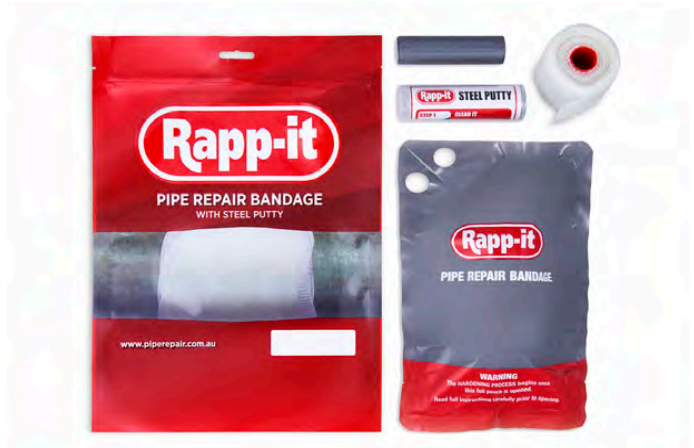
The customer had a leak in their waste poly pipe which had been damaged over time. The pipe was spilling waste and mud which caused a safety hazard for workers around the site.

Pipe Substrate	Poly Pipe
Pipe Contents	Waste, Gravel, Mud
Internal Pressure (psi)	Standard Pressure
Temperature (°C)	10°C - 20°C
Pipe Diameter (mm)	500mm
Damaged Area (mm)	50mm

The customer was able to stem the flow of gravel and waste by using a rubber lining followed by applying several Rapp-it Pipe Repair Bandages (100mm x 4.8m) over the top and around the pipe to completely seal the damaged area. By applying Rapp-it, the customer was able to stop the waste leak and work was able to continue, which saved thousands of dollars in downtime.

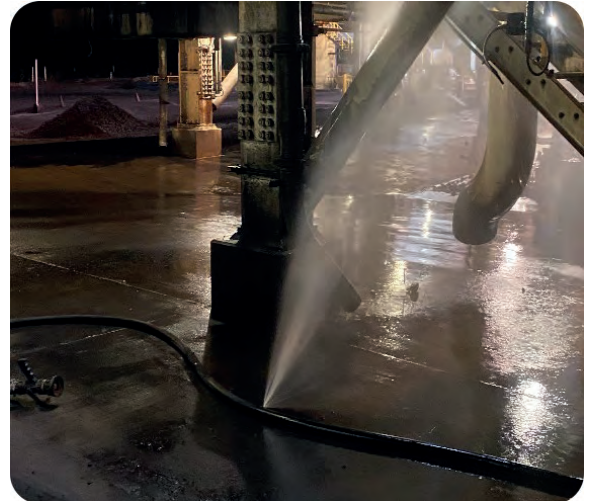
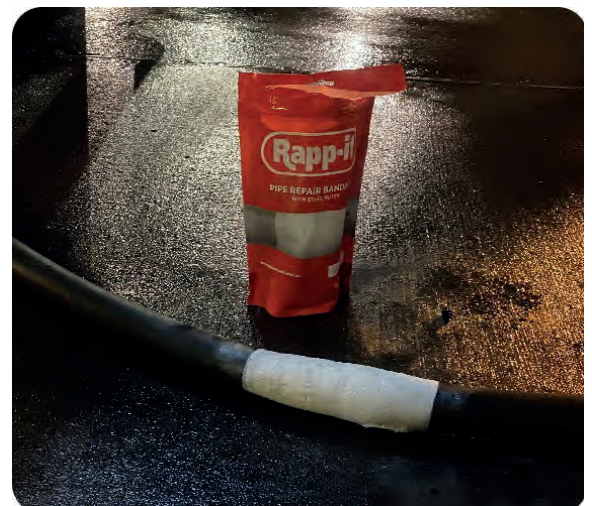
This water hose is used for clearing magnetite sumps at a large coal processing plant. Holes occur regularly in these hoses and it can be very labour intensive to continually change out the hoses, as well as being very costly. Rapp-it allows the hose to be repaired in a short space of time and be put back into service quickly.

Pipe Substrate	Rubber hose
Pipe Contents	Water
Temperature (°C)	Ambient
Pipe Diameter (mm)	50mm
Damaged Area (mm)	Small hole

The customer reduced the pressure of the hose and cleaned and roughened the area. The leak was firstly stemmed with Rapp-it Steel Putty, and a Rapp-it Pipe Repair Bandage (100mm x 3.6m) was then applied over the top. Just 30 minutes after the application, the line was back up and running at full capacity. This one application may have saved the site thousands of dollars in costly downtime.

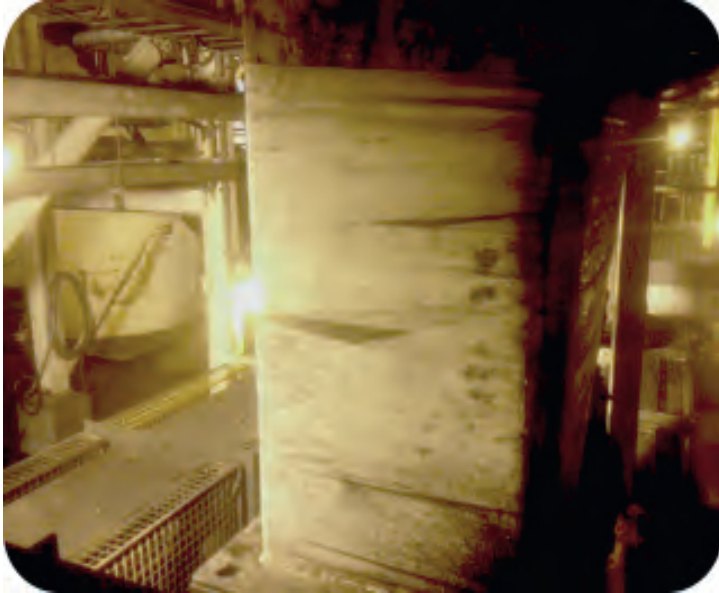
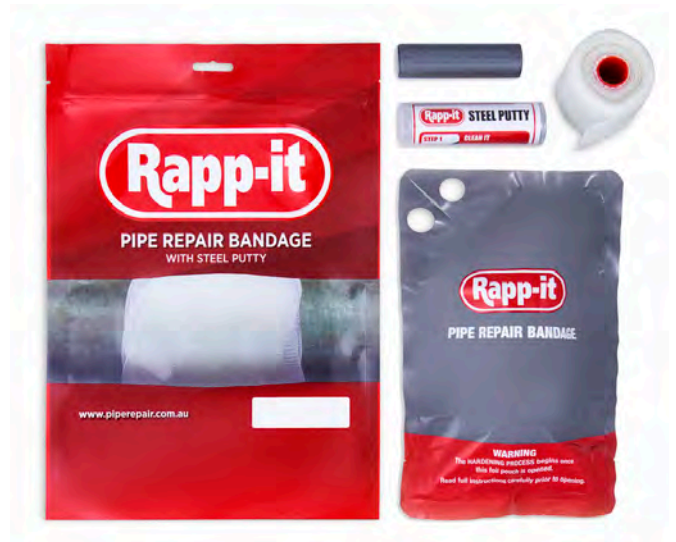
The customer advised the coal discharge chute had a leak. This would require a replacement, however, the power station was unable to stop coal handling processes.

Pipe Substrate	Steel
Pipe Contents	Water
Internal Pressure (psi)	87 psi / 600 kPa
Temperature (°C)	80°C – 140°C
Pipe Diameter (mm)	600mm

The customer used Rapp-it Steel Putty and applied several Rapp-it Pipe Repair Bandages (100mm x 4.8m) to fix the damaged chute. This allowed the customer to continue preparing the coal for export until a maintenance shutdown could be scheduled.

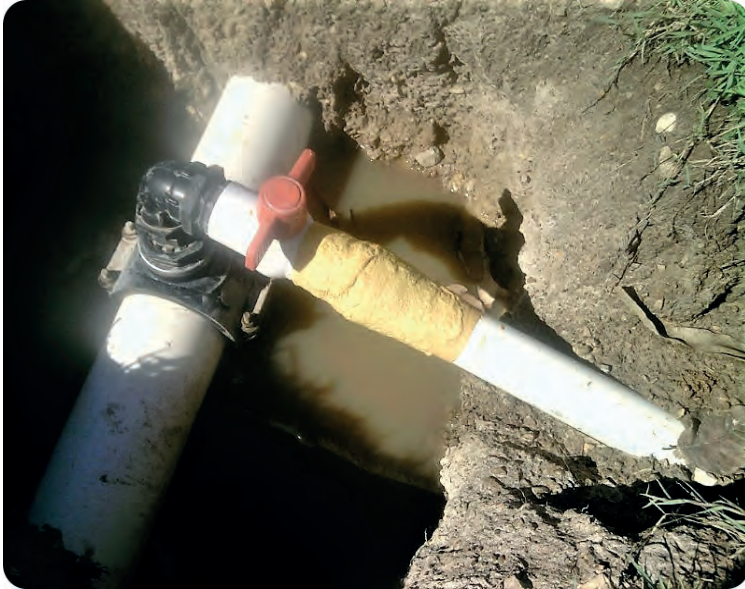
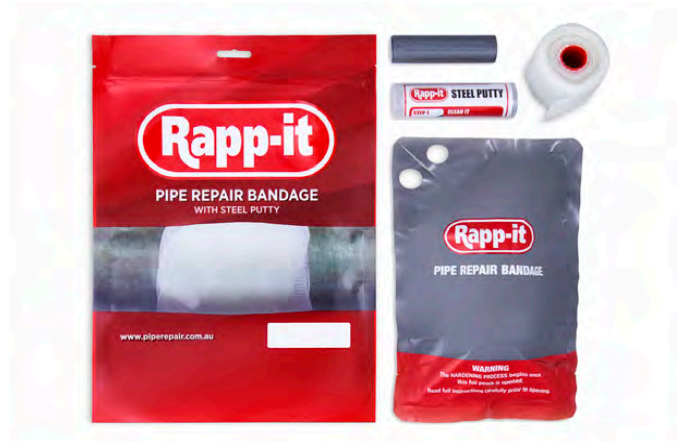
The customer advised that the glue had failed on a 50mm high pressure union leaving a 35mm long crack. Water was leaking out of the irrigation system causing flooding on the golf course.

Pipe Substrate	Poly Pipe
Pipe Contents	Water
Internal Pressure (psi)	87psi / 600kPa
Temperature (°C)	Ambient
Pipe Diameter (mm)	50mm

The customer turned off the water to reduce the pressure and isolate the leak. Using Rapp-it Steel Putty and a Rapp-it Pipe Repair Bandage (100mm x 3.6m), the customer was able to seal the leak. The damage was successfully repaired without needing to replace the poly pipe.

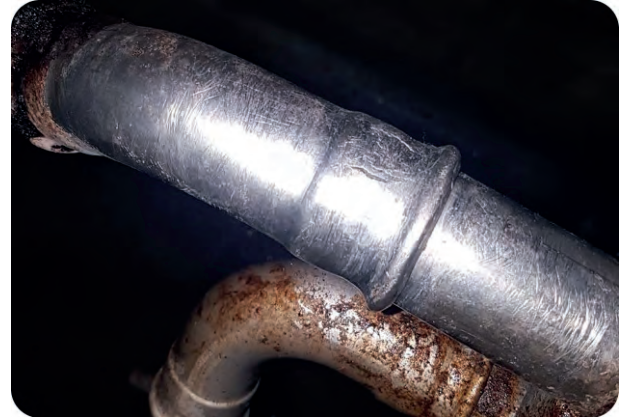
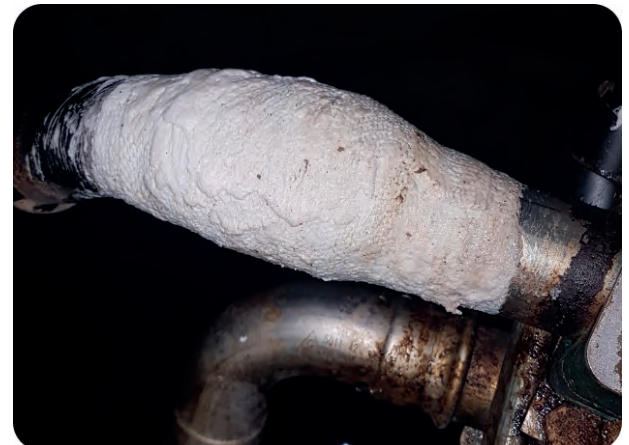
The customer had a crack at the crimped joint on a steam pipe. The pipe required an urgent repair, otherwise an approximate six hour unplanned shutdown maintenance was required. This would have cost the customer thousands of dollars in unnecessary downtime.

Pipe Substrate	Stainless Steel
Pipe Contents	Steam / Air / Low pH water
Internal Pressure (psi)	36psi / 250kPa
Temperature (°C)	130°C
Pipe Diameter (mm)	40mm
Damaged Area (mm)	Crack

The customer cleaned and filed the damaged area. Rapp-it Steel Putty was then applied over the crack and a Rapp-it Pipe Repair Bandage (50mm x 3.6m) was applied over the damaged area. This allowed the pipe to be back up and running at full capacity in short amount of time.

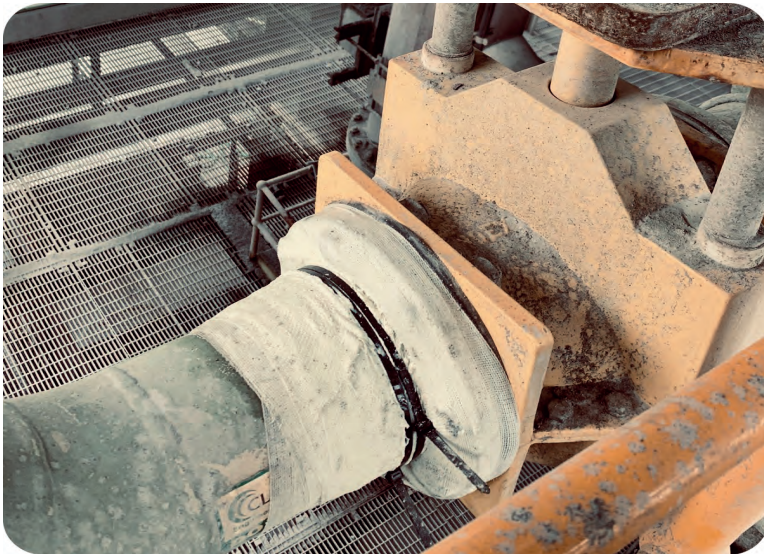
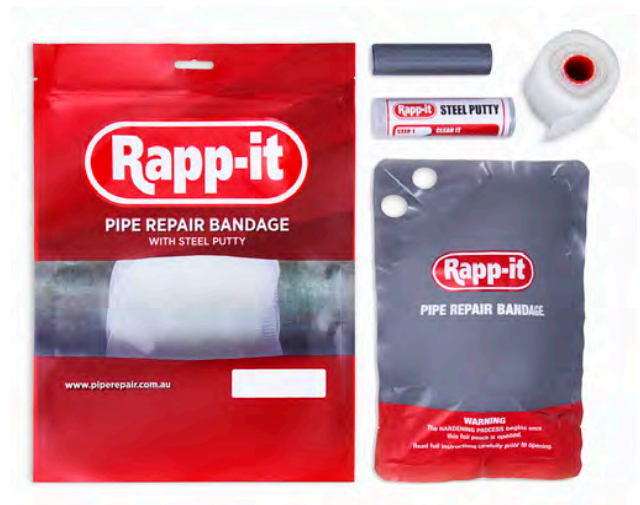
The customer advised the pipe mainly consisted of water with a small amount of fine ore particles (i.e. gold / copper) that were being sent back to the processing plant after the excess rubbish had been removed. The ore was very abrasive, and a small hole had worn out the pipe before the valve. Shutting down the gold plant to replace the pipe would have been costly. Using Rapp-it, the mine could now continue operations until a scheduled maintenance time could be arranged.

Pipe Substrate	Steel
Pipe Contents	Fine ore particles
Internal Pressure (psi)	140 - 160 psi
Temperature (°C)	90°C
Pipe Diameter (mm)	150mm
Damaged Area (mm)	Crack

The customer roughened and cleaned the damaged area of the pipe before applying Rapp-it Steel Putty over the hole. Then they applied a Rapp-it Pipe Repair Bandage (100mm x 9m) to the pipe before the valve. The customer was successful in repairing the damaged pipe without having to shutdown the processing facility.

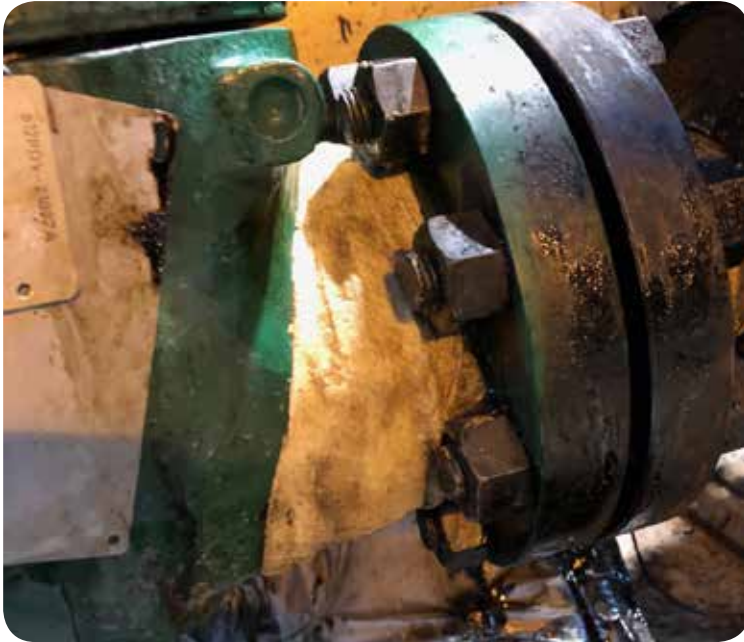
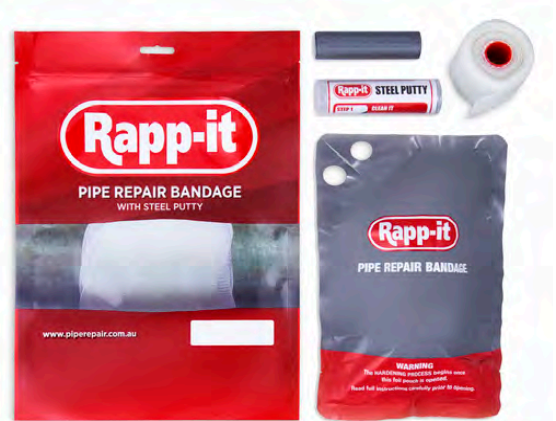
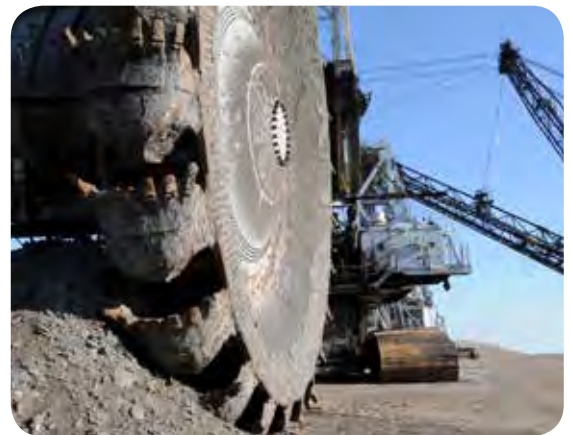
The customer had a rupture on a water line 350mm pipe. The mine was subject to frigid conditions of -26°C.

Pipe Substrate	Steel
Pipe Contents	Water
Internal Pressure (psi)	87psi / 600kPa
Temperature (°C)	Ambient
Pipe Diameter (mm)	350mm

The customer shut down the pipe line and then utilised a Herman Nelson heater and sock placed right at the patch location to maintain a moderate temperature. They then cleaned and roughened the damaged area. The leak was stemmed with Rapp-it Steel Putty and Rapp-it Pipe Repair Bandages (100mm x 3.6m) were applied over the top. The line was up and running at full capacity, 30 minutes after application.

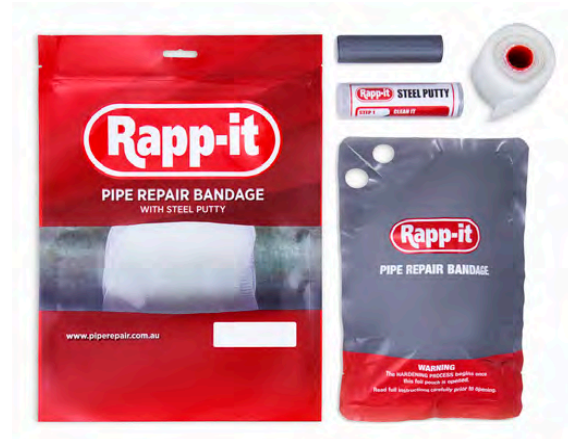
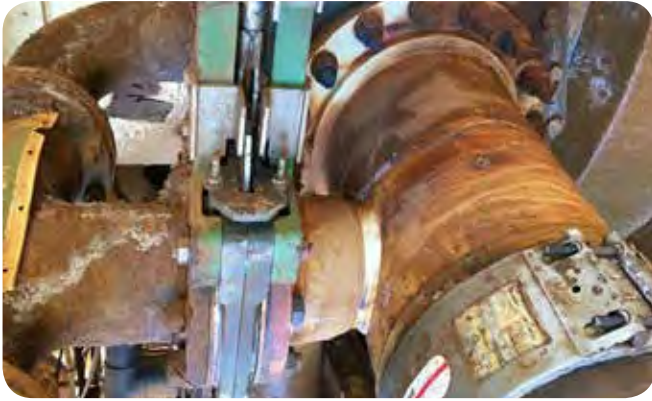
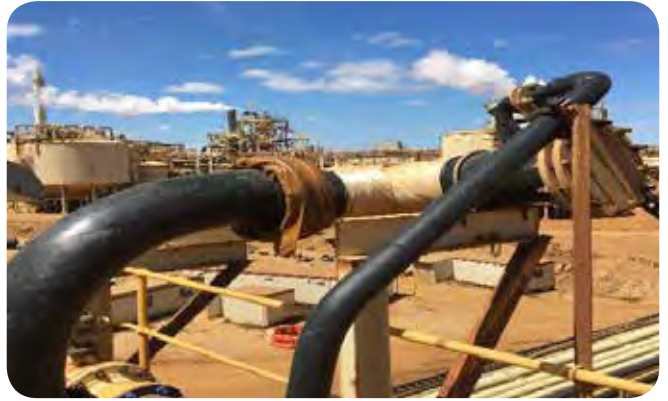
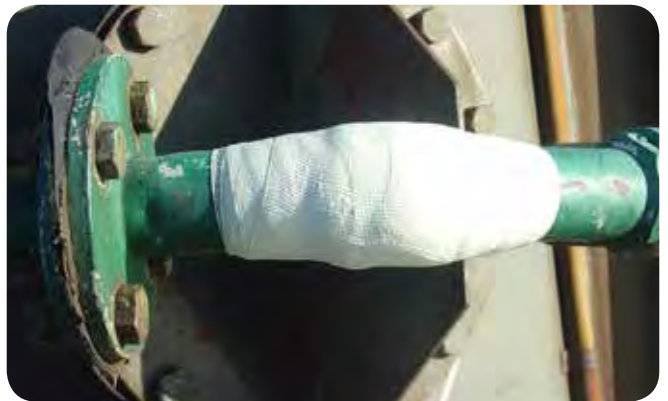
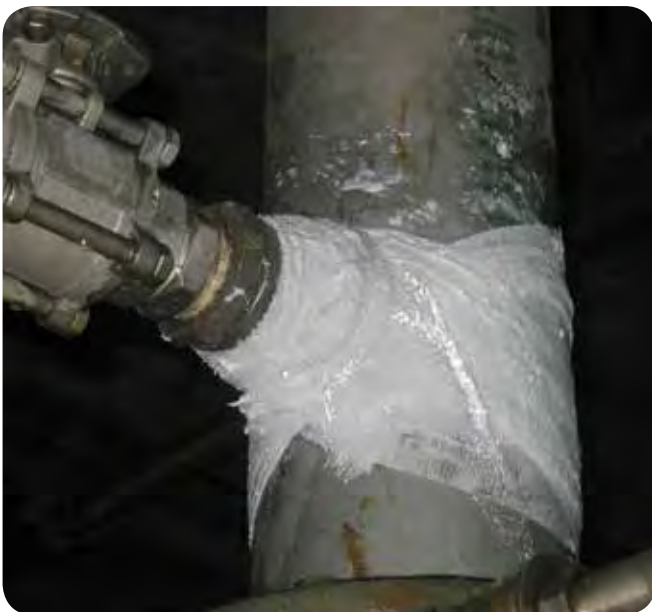
The customer's concentrator throughput was approximately 25 million TPA and had 4 main outages per year at 12-week intervals. The biggest wear issues were in pipes throughout the concentrator as the slurry was very abrasive as with most mining in grinding. Although the pipes were rubber lined and, in some cases, also ceramic lined for the high wear areas, they had the occasional pipe failure, with slurry leaking from either a pipe's bend (elbow), flange or valve body.

- 500mm slurry and coarse material piping and valve body leaks were contained and sealed up using Rapp-it Pipe Repair Bandages (100mm x 9m).
- 550mm tailings pipe line leaks were successfully wrapped and sealed using Linatex rubber and wrapped with many rolls of Rapp-it Pipe Repair Bandages (100mm x 3.6m).
- Cyclone feed spool and coarse overflow spool repairs were conducted using Rapp-it Pipe Repair Bandages (50mm x 3.6m).
- Many airline pipe pin hole leaks were detected at an early stage and wrapped and sealed using the smaller Rapp-it Pipe Repair Bandage (50mm x 3.6m).

All repairs above were able to be successfully completed using Rapp-it Pipe Repair Bandages. Rapp-it set as hard as a rock and stopped the leaks.
