PIPE REPAIR BANDAGE
CASE STUDIES

www.piperepair.com.au
MARINE & INDUSTRIAL MARKETING PTY LTD

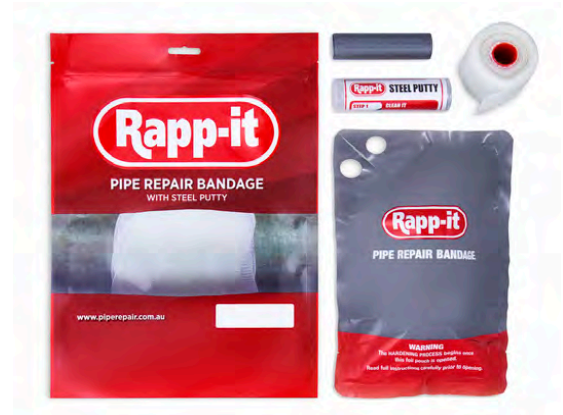
The customer advised they had a leak in the acid column outlet bend to the extraction column as part of the stripping circuit in gold production. The bend had previously been repaired with a steel patch, but a leak occurred just above the repair weld.

Pipe Substrate	Steel
Pipe Contents	Saturated carbon, hydrochloric acid, caustic solution
Pipe Diameter (mm)	100mm
Damaged Area (mm)	Pin-hole leak

The customer reduced the line pressure and then cleaned and roughened the area. The leak was stemmed with Rapp-it Steel Putty and a Rapp-it Pipe Repair Bandage (100mm x 3.6m) applied over the top. The line was up and running at full capacity, 30 minutes after application.

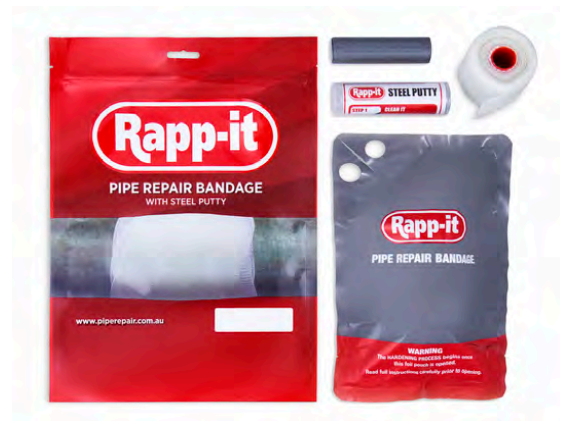
The customer advised that they had an overhead leak in a 100mm water main line. The pipe required urgent repair, as the damaged area was dangerously close to electrical conduits which was creating a safety hazard.

Pipe Substrate	Steel
Pipe Contents	Water
Internal Pressure (psi)	116 psi / 800 kPa
Temperature (°C)	7°C – 15°C
Pipe Diameter (mm)	100mm
Damaged Area (mm)	180mm

The customer reduced the line pressure and then cleaned and roughened the damaged area. The leak was plugged with Rapp-it Steel Putty and Rapp-it Pipe Repair Bandages (100mm x 4.8m) were applied over the top. The line was fully functional 30 minutes after application.

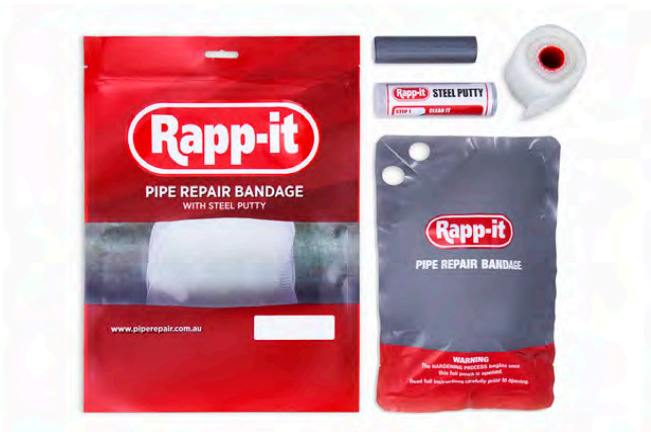
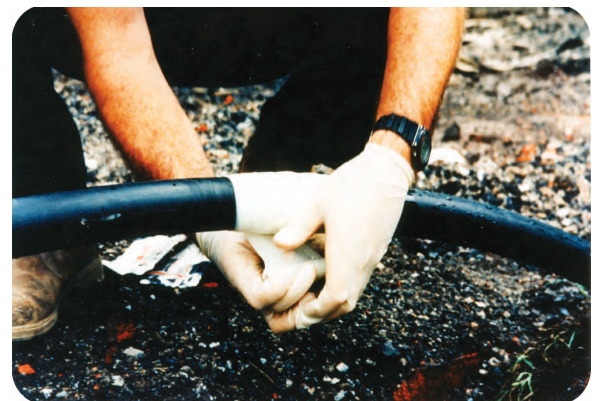
The customer had a leak on a poly pipe water line feeding the job site. The pipe could not be shut down and required an urgent temporary repair, as the water spillage on the ground was creating a safety hazard for construction workers accessing the area.

Pipe Substrate	Poly Pipe
Pipe Contents	Water
Internal Pressure (psi)	100 psi / 690 kPa
Temperature (°C)	Ambient
Pipe Diameter (mm)	100mm

The customer decreased the line pressure and then cleaned the area. As the leak was located close to a poly joiner, we advised that Rapp-it should be applied over the joiner to ensure the leak would be fully contained. Using Rapp-it Steel Putty and a Rapp-it Pipe Repair Bandage (100mm x 3.6m) applied over the joiner, the leak was successfully contained within 30 minutes with no further spillage onsite.

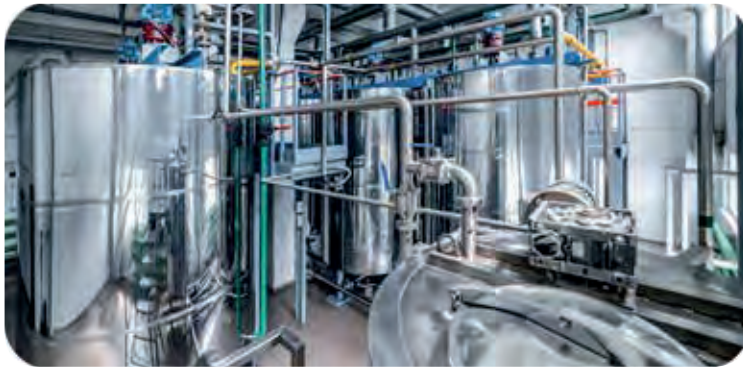
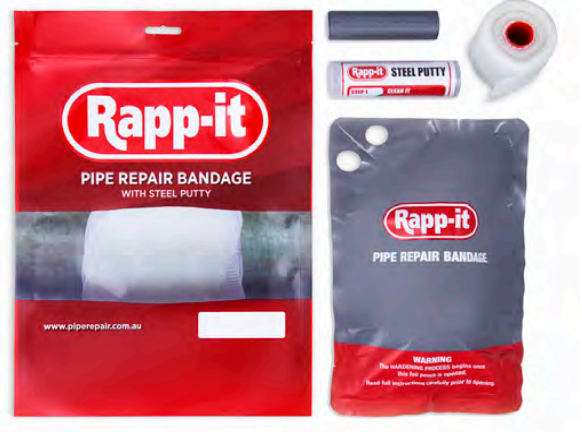
The customer had an overhead leak in a corroded line at 2 o'clock in the morning. The pipe required urgent repair, as water spillage on the ground was creating a safety hazard for staff accessing the area.

Pipe Substrate	Steel
Pipe Contents	Water
Internal Pressure (psi)	150 psi / 1034 kPa
Temperature (°C)	Ambient
Pipe Diameter (mm)	250mm
Damaged Area (mm)	180mm

The pressure in the line was reduced and the corroded area was cleaned and roughened. The leak was stemmed with Rapp-it Steel Putty and a Rapp-it Pipe Repair Bandage (100mm x 9m) applied over the top. The line was back up and running at full capacity 30 minutes after application.

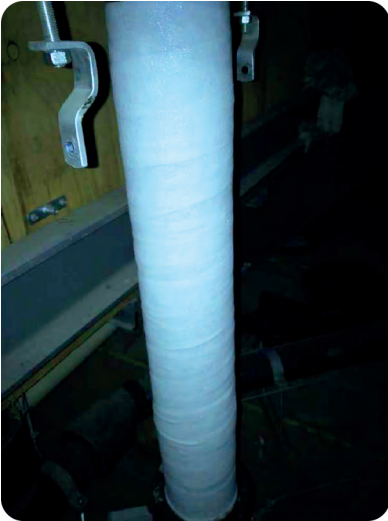
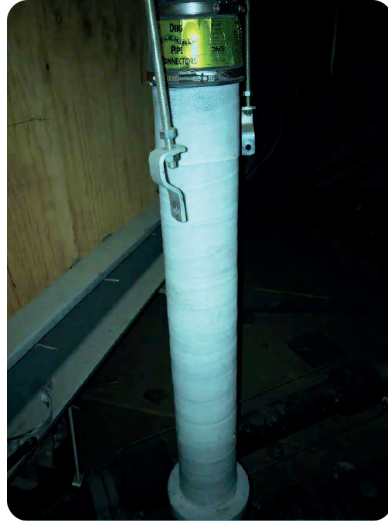
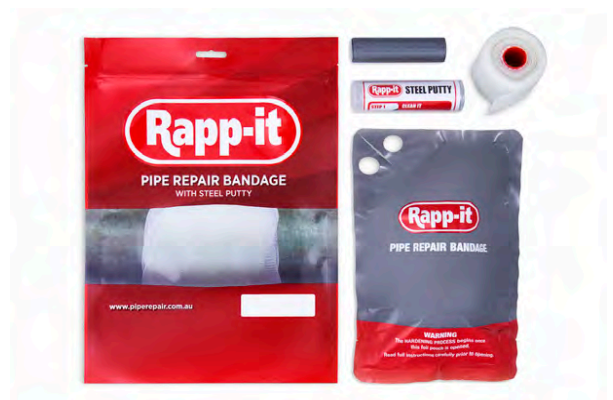
The customer had a leak in their 1992 vintage cement storm water run-off pipes. The pipes required urgent repair, as the damaged area was dangerously close to electrical, lighting and costumes. This was creating a safety hazard for all staff and patrons, as well as potentially damaging thousands of dollars worth of costumes.

Pipe Substrate	Cement
Pipe Contents	Water run off
Internal Pressure (psi)	100 psi / 690 kPa
Temperature (°C)	10°C – 20°C
Pipe Diameter (mm)	100mm
Damaged Area (mm)	20mm

After the customer stemmed the flow of water, and cleaned and roughened the pipe, they used Rapp-it Steel Putty and a Rapp-it Pipe Repair Bandage (50mm x 3.6m) to seal the leak. The successful application ensured no risk to staff or patrons, or costume damage.

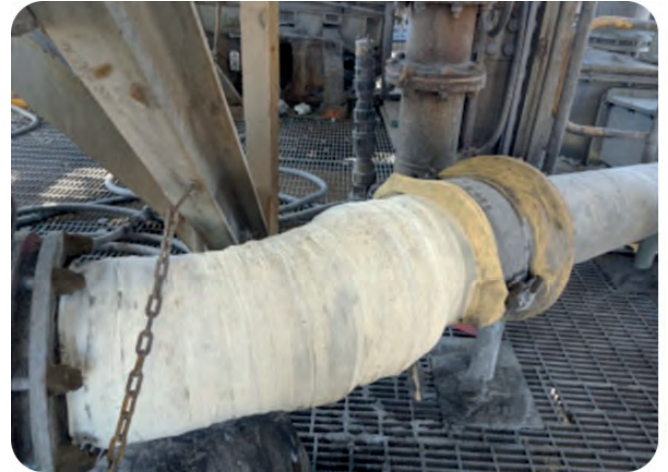
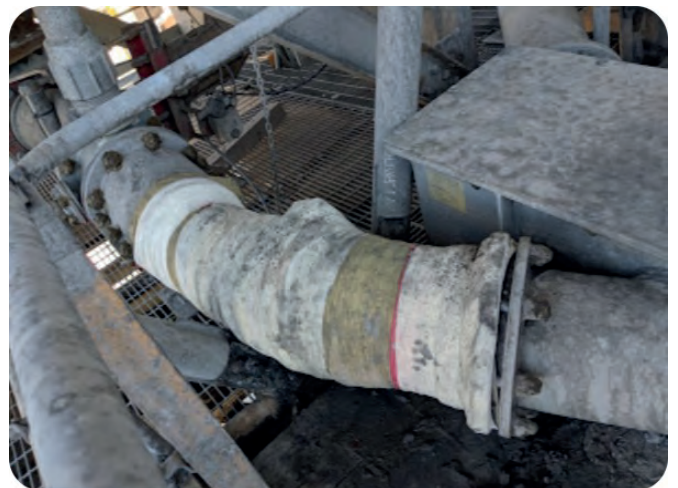
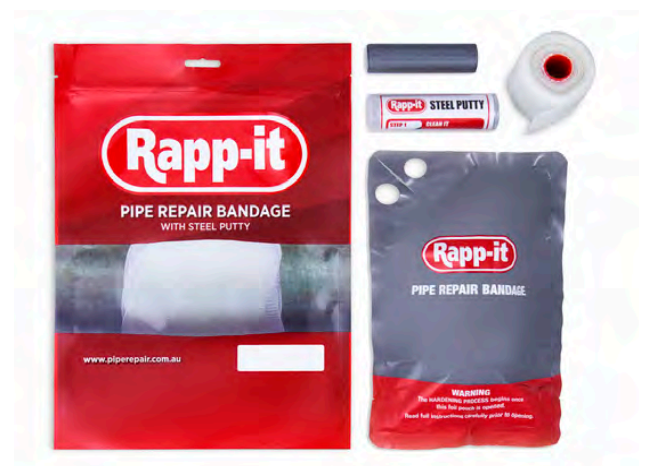
The customer had a damaged material handling hose due to the pressure and contents of the mineral ore running through it. The hose required an urgent repair or unplanned shutdown maintenance was needed, potentially costing thousands of dollars in unnecessary downtime.

Pipe Substrate	Industrial rubber hose
Pipe Contents	Nickel sludge
Internal Pressure (psi)	117 psi / 800 kPa
Temperature (°C)	0°C - 45°C
Pipe Diameter (mm)	250mm
Damaged Area (mm)	Multiple damaged areas

Industrial hoses are great for transferring harsh and abrasive products throughout processing facilities. However, sometimes abrasive materials can impact the integrity of the hose. In this example, the customer was unable to weld or clamp the hose. The customer applied 23 Rapp-it Pipe Repair Bandages (100mm x 4.8m) around the damaged area. The material handling hose was up and running at full capacity just 30 minutes after application.

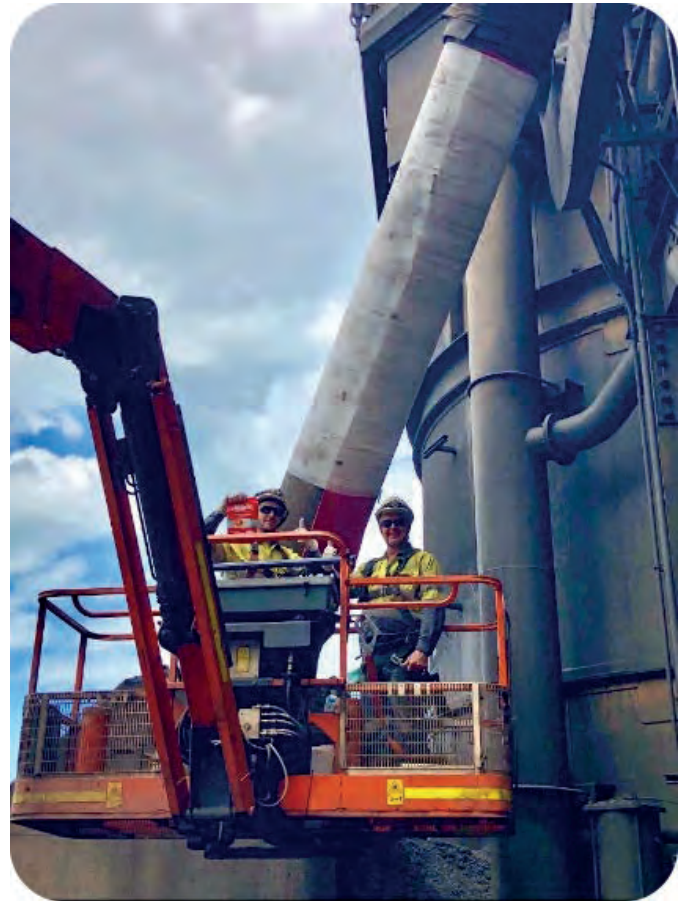
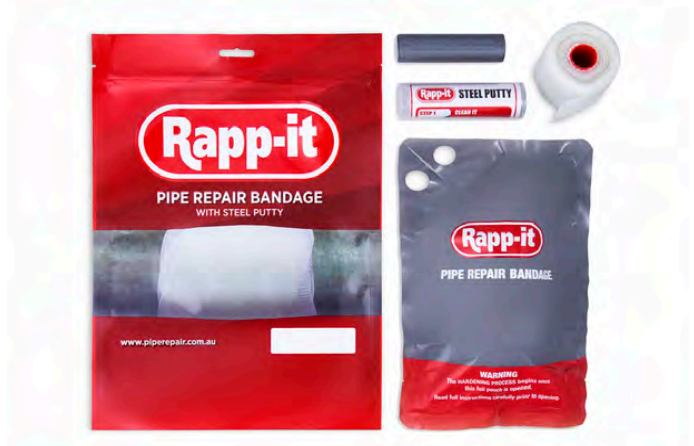
The customer had a leak in their waste poly pipe which had been damaged over time. The pipe was spilling waste and mud which caused a safety hazard for workers around the site.

Pipe Substrate	Poly Pipe
Pipe Contents	Waste, Gravel, Mud
Internal Pressure (psi)	Standard Pressure
Temperature (°C)	10°C - 20°C
Pipe Diameter (mm)	500mm
Damaged Area (mm)	50mm

The customer was able to stem the flow of gravel and waste by using a rubber lining followed by applying several Rapp-it Pipe Repair Bandages (100mm x 4.8m) over the top and around the pipe to completely seal the damaged area. By applying Rapp-it, the customer was able to stop the waste leak and work was able to continue, which saved thousands of dollars in downtime.

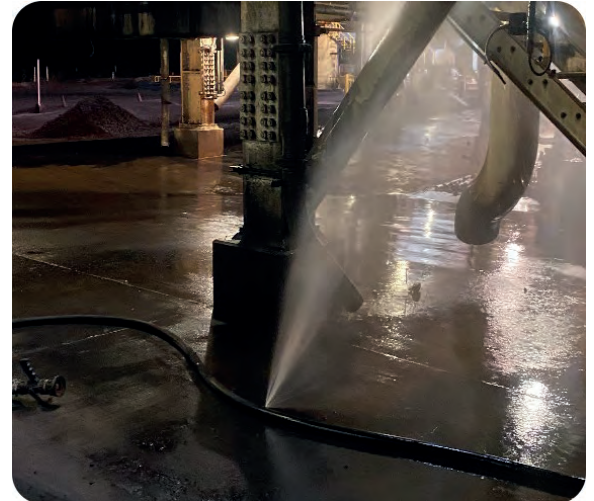
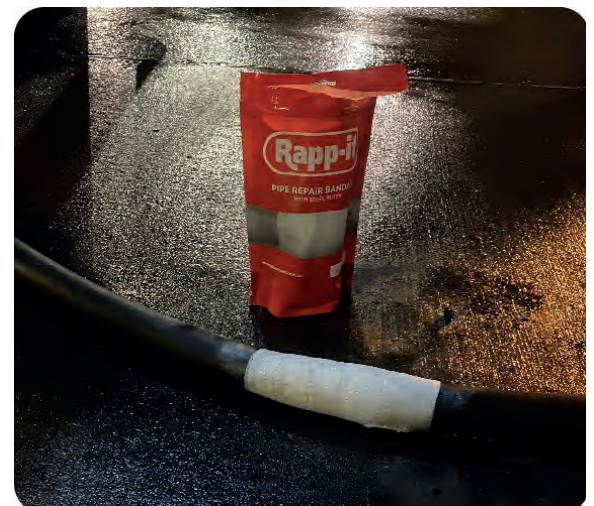
This water hose is used for clearing magnetite sumps at a large coal processing plant. Holes occur regularly in these hoses and it can be very labour intensive to continually change out the hoses, as well as being very costly. Rapp-it allows the hose to be repaired in a short space of time and be put back into service quickly.

Pipe Substrate	Rubber hose
Pipe Contents	Water
Temperature (°C)	Ambient
Pipe Diameter (mm)	50mm
Damaged Area (mm)	Small hole

The customer reduced the pressure of the hose and cleaned and roughened the area. The leak was firstly stemmed with Rapp-it Steel Putty, and a Rapp-it Pipe Repair Bandage (100mm x 3.6m) was then applied over the top. Just 30 minutes after the application, the line was back up and running at full capacity. This one application may have saved the site thousands of dollars in costly downtime.

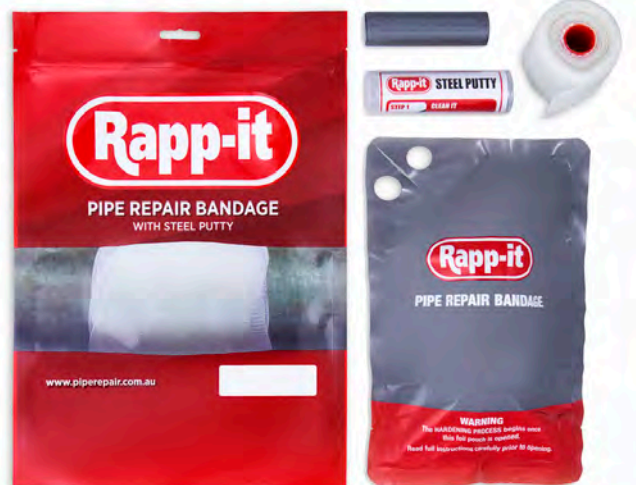
The customer advised the coal discharge chute had a leak. This would require a replacement, however, the power station was unable to stop coal handling processes.

Pipe Substrate	Steel
Pipe Contents	Water
Internal Pressure (psi)	87 psi / 600 kPa
Temperature (°C)	80°C - 140°C
Pipe Diameter (mm)	600mm

The customer used Rapp-it Steel Putty and applied several Rapp-it Pipe Repair Bandages (100mm x 4.8m) to fix the damaged chute. This allowed the customer to continue preparing the coal for export until a maintenance shutdown could be scheduled.

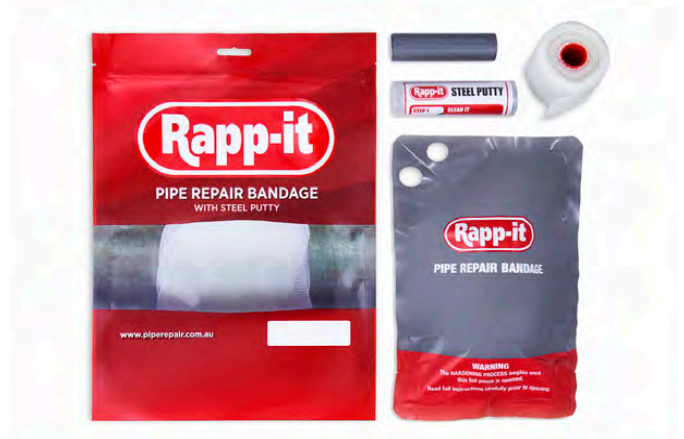
The customer advised that the glue had failed on a 50mm high pressure union leaving a 35mm long crack. Water was leaking out of the irrigation system causing flooding on the golf course.

Pipe Substrate	Poly Pipe
Pipe Contents	Water
Internal Pressure (psi)	87psi / 600kPa
Temperature (°C)	Ambient
Pipe Diameter (mm)	50mm

The customer turned off the water to reduce the pressure and isolate the leak. Using Rapp-it Steel Putty and a Rapp-it Pipe Repair Bandage (100mm x 3.6m), the customer was able to seal the leak. The damage was successfully repaired without needing to replace the poly pipe.

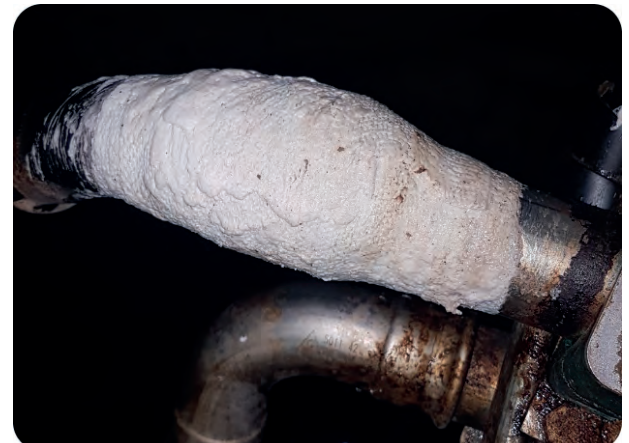
The customer had a crack at the crimped joint on a steam pipe. The pipe required an urgent repair, otherwise an approximate six hour unplanned shutdown maintenance was required. This would have cost the customer thousands of dollars in unnecessary downtime.

Pipe Substrate	Stainless Steel
Pipe Contents	Steam / Air / Low pH water
Internal Pressure (psi)	36psi / 250kPa
Temperature (°C)	130°C
Pipe Diameter (mm)	40mm
Damaged Area (mm)	Crack

The customer cleaned and filed the damaged area. Rapp-it Steel Putty was then applied over the crack and a Rapp-it Pipe Repair Bandage (50mm x 3.6m) was applied over the damaged area. This allowed the pipe to be back up and running at full capacity in short amount of time.

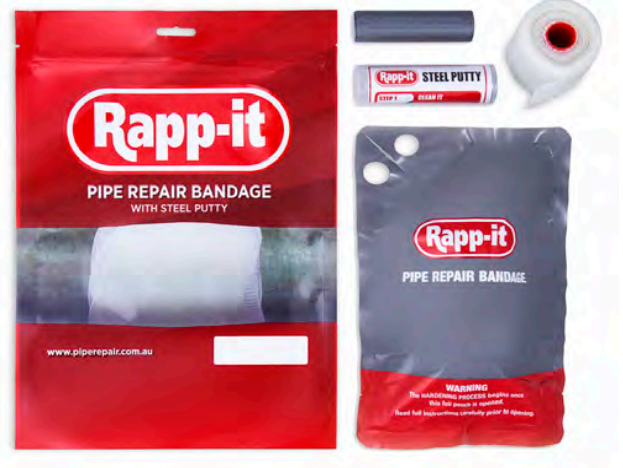
The customer advised the pipe mainly consisted of water with a small amount of fine ore particles (i.e. gold / copper) that were being sent back to the processing plant after the excess rubbish had been removed. The ore was very abrasive, and a small hole had worn out the pipe before the valve. Shutting down the gold plant to replace the pipe would have been costly. Using Rapp-it, the mine could now continue operations until a scheduled maintenance time could be arranged.

Pipe Substrate	Steel
Pipe Contents	Fine ore particles
Internal Pressure (psi)	140 - 160 psi
Temperature (°C)	90°C
Pipe Diameter (mm)	150mm
Damaged Area (mm)	Crack

The customer roughened and cleaned the damaged area of the pipe before applying Rapp-it Steel Putty over the hole. Then they applied a Rapp-it Pipe Repair Bandage (100mm x 9m) to the pipe before the valve. The customer was successful in repairing the damaged pipe without having to shutdown the processing facility.

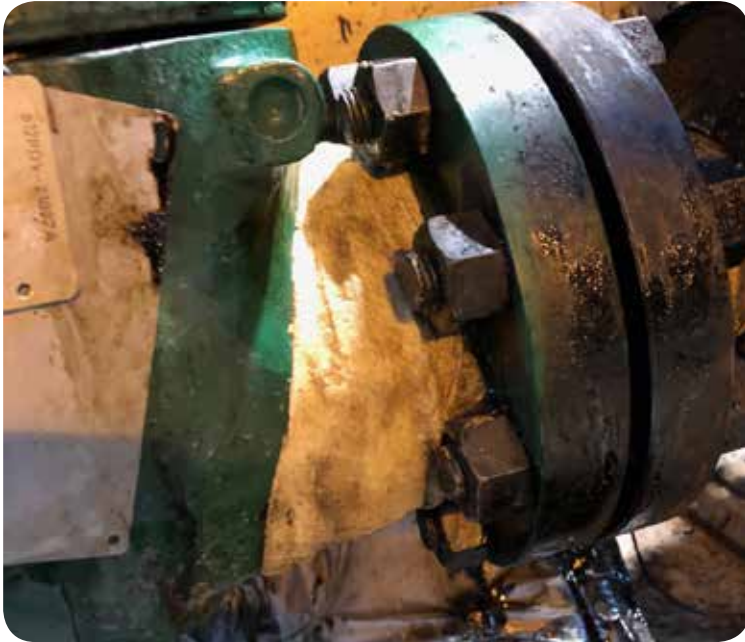
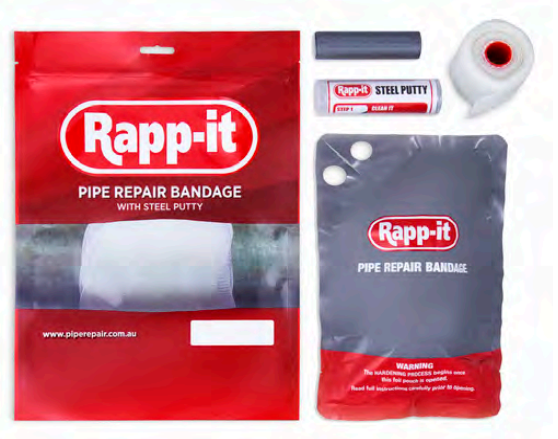
The customer had a rupture on a water line 350mm pipe. The mine was subject to frigid conditions of -26°C.

Pipe Substrate	Steel
Pipe Contents	Water
Internal Pressure (psi)	87psi / 600kPa
Temperature (°C)	Ambient
Pipe Diameter (mm)	350mm

The customer shut down the pipe line and then utilised a Herman Nelson heater and sock placed right at the patch location to maintain a moderate temperature. They then cleaned and roughened the damaged area. The leak was stemmed with Rapp-it Steel Putty and Rapp-it Pipe Repair Bandages (100mm x 3.6m) were applied over the top. The line was up and running at full capacity, 30 minutes after application.

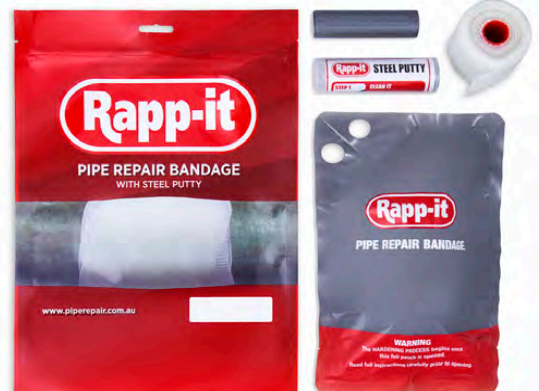
The customer's concentrator throughput was approximately 25 million TPA and had 4 main outages per year at 12-week intervals. The biggest wear issues were in pipes throughout the concentrator as the slurry was very abrasive as with most mining in grinding. Although the pipes were rubber lined and, in some cases, also ceramic lined for the high wear areas, they had the occasional pipe failure, with slurry leaking from either a pipe's bend (elbow), flange or valve body.

- 500mm slurry and coarse material piping and valve body leaks were contained and sealed up using Rapp-it Pipe Repair Bandages (100mm x 9m).
- 550mm tailings pipe line leaks were successfully wrapped and sealed using Linatex rubber and wrapped with many rolls of Rapp-it Pipe Repair Bandages (100mm x 3.6m).
- Cyclone feed spool and coarse overflow spool repairs were conducted using Rapp-it Pipe Repair Bandages (50mm x 3.6m).
- Many airline pipe pin hole leaks were detected at an early stage and wrapped and sealed using the smaller Rapp-it Pipe Repair Bandage (50mm x 3.6m).

All repairs above were able to be successfully completed using Rapp-it Pipe Repair Bandages. Rapp-it set as hard as a rock and stopped the leaks.
