# EMERGENCY PIPE REPAIR SOLUTION FOR CONSTRUCTION PROJECTS

### Emergency Repair Solution for Construction Sites

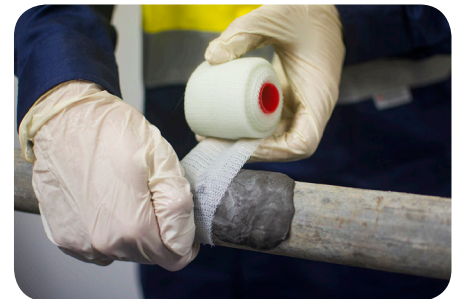
### Rapp-it Pipe Repair Bandages

- Each kit includes a fibreglass bandage, 90mm stick of Rapp-it Steel Putty and a pair of nitrile gloves.
- Heat Resistance – 150°C
- Pressure Resistance – 2500kPa (360 psi).
- Potable water tested (AS/NZ 4020:2005).
- Available in five convenient sizes, to suit pipes from 25mm to 250mm diameter.

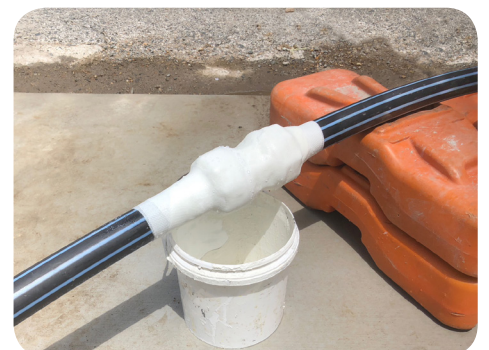
The customer advised that they had a leak on a poly pipe water line feeding the job site. The pipe could not be shut down and required urgent temporary repair, as water spillage on the ground was creating a safety hazard for construction workers accessing the area.

- Pipe Substrate: Poly pipe
- Pipe Contents: Water
- Internal Pressure: 100psi
- Temperature: Ambient
- Pipe Diameter: 100mm
- Damaged area: 50mm

The customer reduced the line pressure and then cleaned the area. As the leak was located close to a poly joiner, it was advised that Rapp-it be applied over the joiner to ensure the leak would be fully contained. The leak was stemmed with Rapp-it Steel Putty and a RAP124 was applied over the top. The leak was successfully contained within 30 minutes, with no further spillage onsite.
