## PIPE REPAIR BANDAGE

# METALLIFEROUS MINES

### EMERGENCY REPAIR SOLUTION FOR METALLIFEROUS MINES GOLD

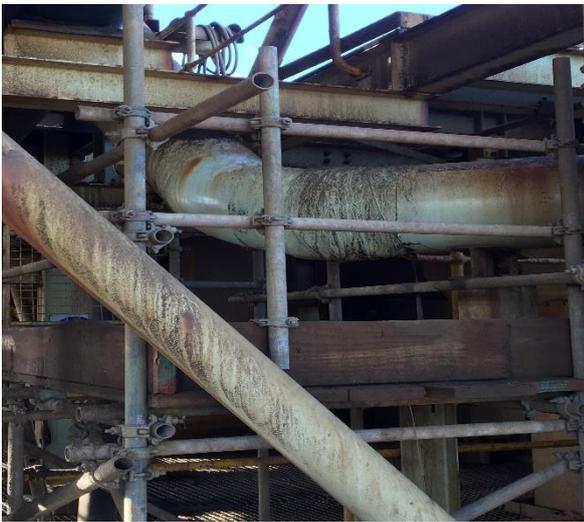
**400mm SLURRY PIPE CYCLONE FEED**

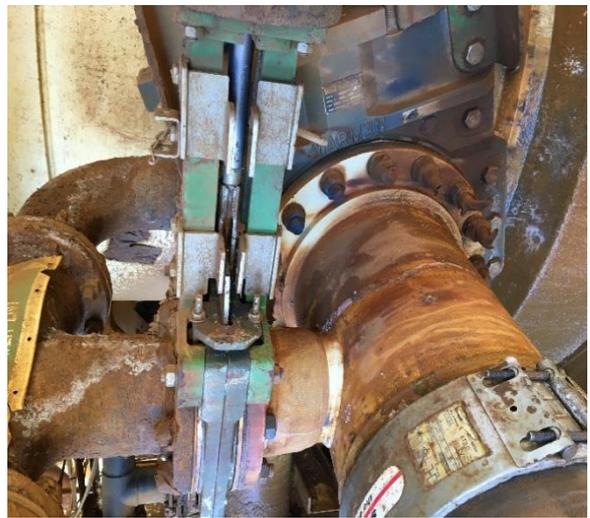
**200mm VALVE FLANGE**

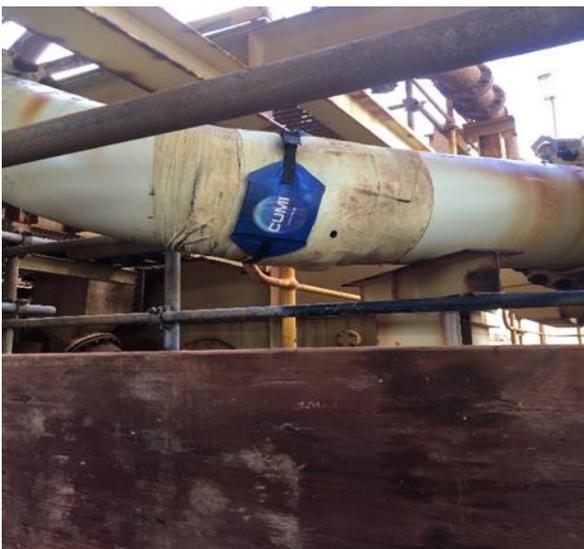
**400NB SLURRY PIPE**

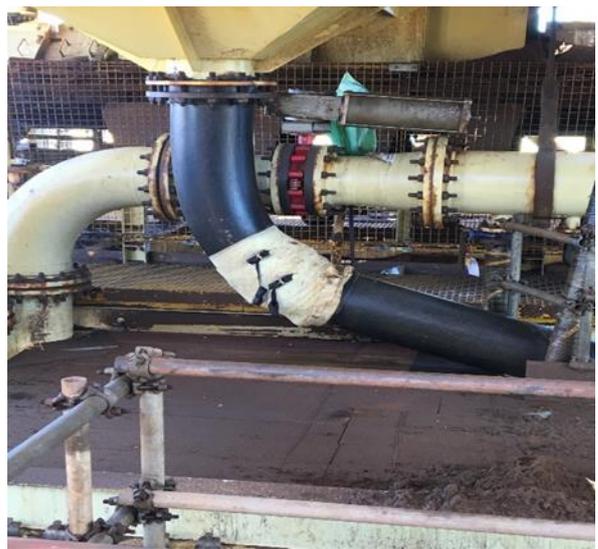
**350mm POLY DRAIN PIPE**

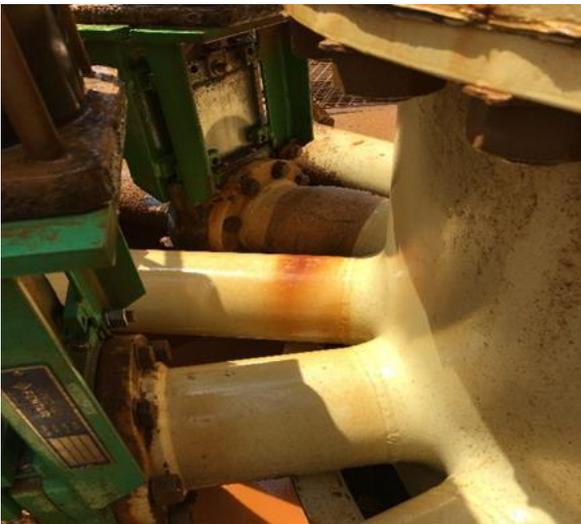
**250mm CYCLONE FEED SPOOL**

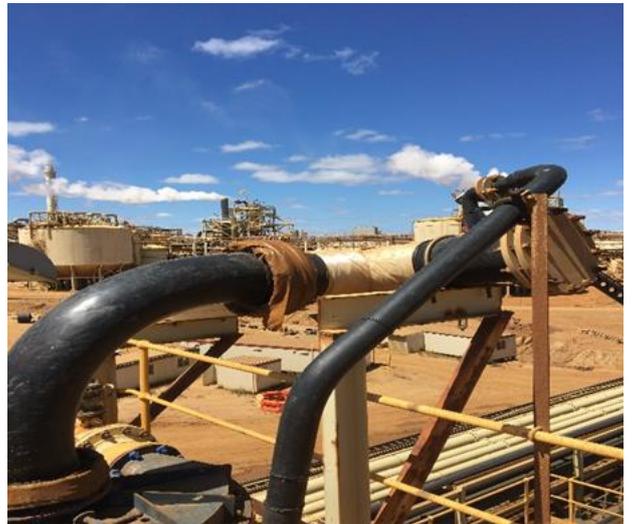
**200mm SLURRY POLY LINE ELBOW**

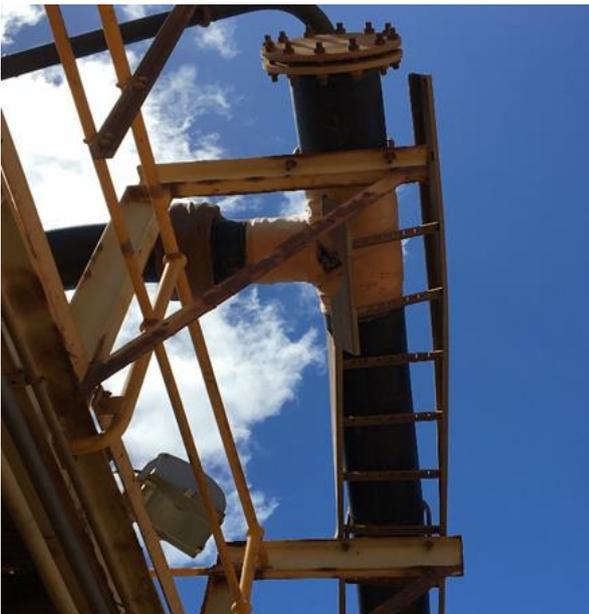
**300mm T-PIECE REPAIR (SCREEN FINES)**

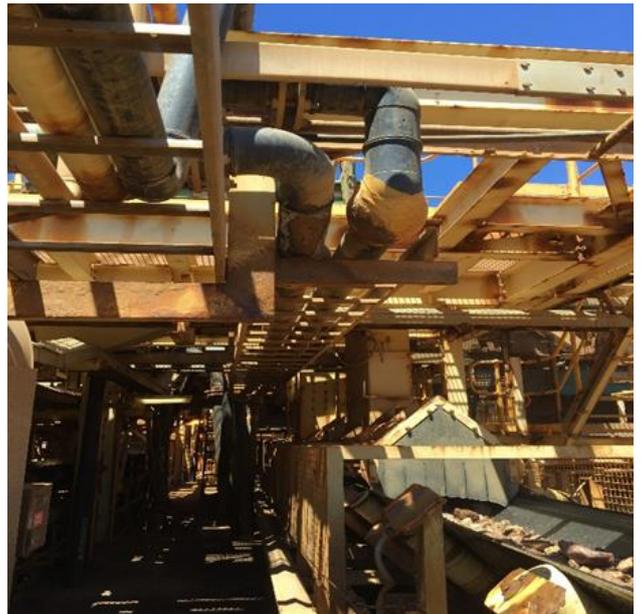
**200mm POLY REPAIR ELBOW**
