PIPE REPAIR BANDAGE

INDUSTRIAL HOSE CASE STUDY

EMERGENCY REPAIR SOLUTION FOR INDUSTRIAL HOSES

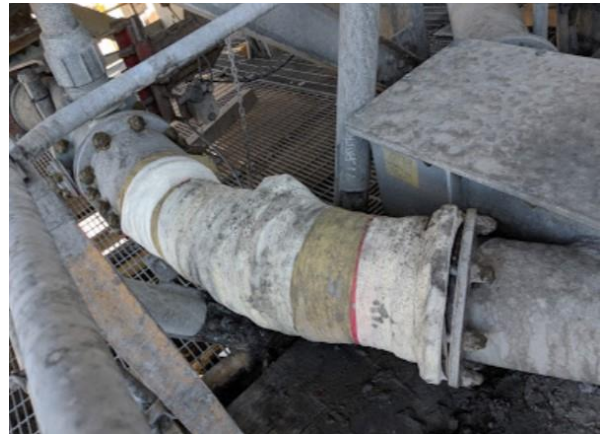
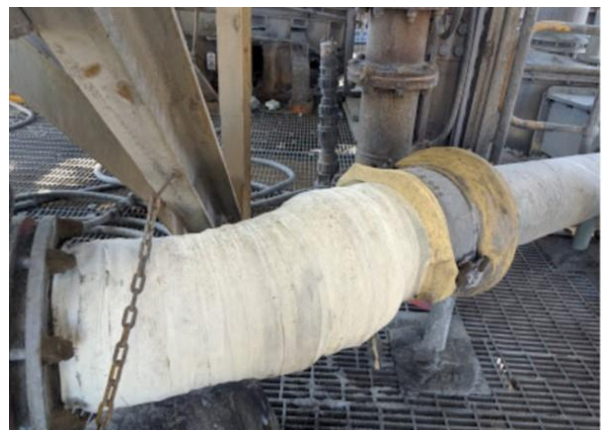
The customer advised that they had a damaged material handling hose due to the pressure and contents of the mineral ore running through it. The hose required an urgent repair or unplanned shutdown maintenance was needed, costing thousands of dollars in unnecessary downtime.

Pipe Substrate	Industrial Rubber Hose
Pipe Contents	Nickel sludge
Internal Pressure (psi)	117psi / 800kPa
Temperature (°C)	0°C – 45°C
Pipe Diameter (mm)	250mm
Damaged Area (mm)	Multiple damaged areas

Industrial hoses are great for transferring harsh and abrasive products throughout processing facilities. However, sometimes abrasive materials can impact the integrity of the hose. In these two examples, the customer was unable to weld or clamp the hose. The customer applied 23 Rapp-it Pipe Repair Bandages (100mm x 4.8m) around the damaged area. The materials handling hose was up and running at full capacity 30 minutes after application.
