## PIPE REPAIR BANDAGE

# WASTE TREATMENT PLANT CASE STUDY

### EMERGENCY REPAIR SOLUTION FOR WASTE TREATMENT PLANT

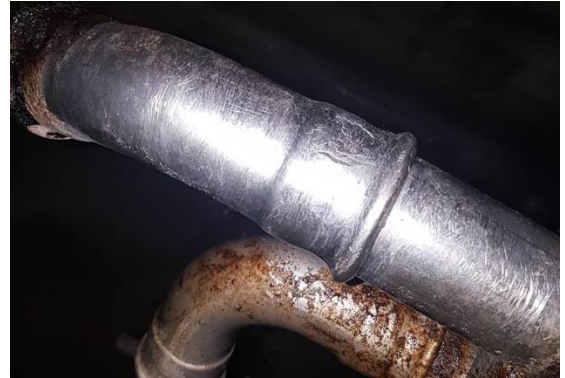
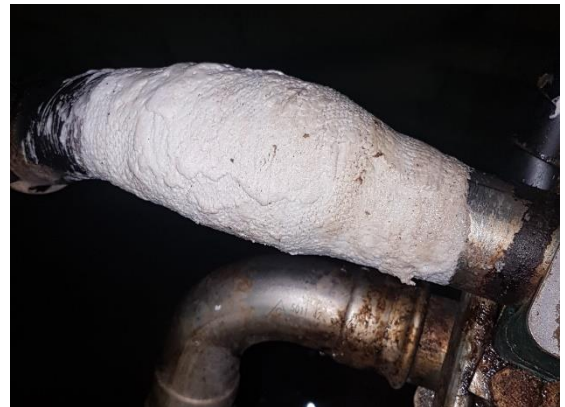
Stainless steel steam pipes are used to quarantine waste in waste treatment plants. However, sometimes abrasive materials can contaminate the steam which can impact the integrity of the pipe. The customer advised that they had a crack at the crimped joint on the steam pipe. The pipe required an urgent repair otherwise approximately a 6-hour unplanned shutdown maintenance was needed, costing thousands of dollars in unnecessary downtime.

Pipe Substrate	Stainless steel
Pipe Contents	Steam / Air / Low pH water
Internal Pressure (psi)	36psi / 250kPa (+/- pressure)
Temperature (°C)	130°C
Pipe Diameter (mm)	40mm
Damaged Area (mm)	Crack

The customer cleaned and filed the damaged area. The customer then applied Rapp-it Steel Putty around the crack and Rapp-it Pipe Repair Bandage (50mm x 3.6m) around the damaged area. The steel pipe was up and running at full capacity 30 minutes after applying Rapp-it.
