PIPE REPAIR BANDAGE

# ACID LINE CASE STUDY

## EMERGENCY REPAIR SOLUTION FOR ACID LINES

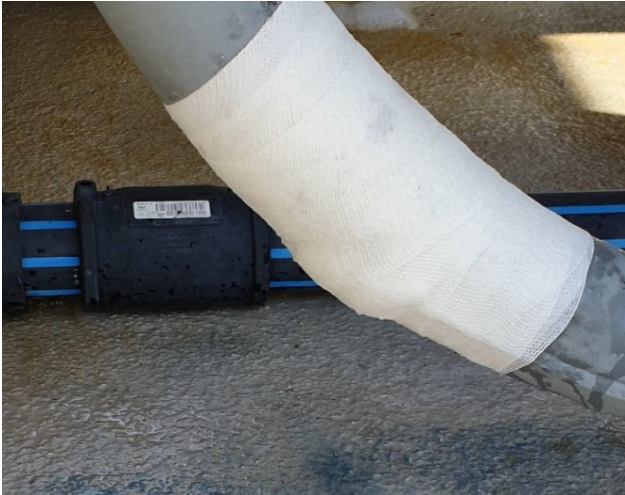
The customer advised they had a leak in the acid column outlet bend to the extraction column as part of the stripping circuit on gold production. The bend had already been repaired previously with a steel patch, but a leak occurred just above the repair weld.

Pipe Substrate	Steel
Pipe Contents	Saturated carbon, hydrochloric acid 30%, caustic solution 50%
Pipe Diameter (mm)	100mm
Damaged Area (mm)	Pin-hole leak

The customer reduced the line pressure and then cleaned and roughened the area. The leak was stemmed with Rapp-it Steel Putty and a RAP124 was applied over the top. The line was up and running at full capacity, 30 minutes after application.
